## The no-dig trenchless solution.

The Snap-Tite® HDPE **Lining System is ideal** for failing metal and concrete culverts.

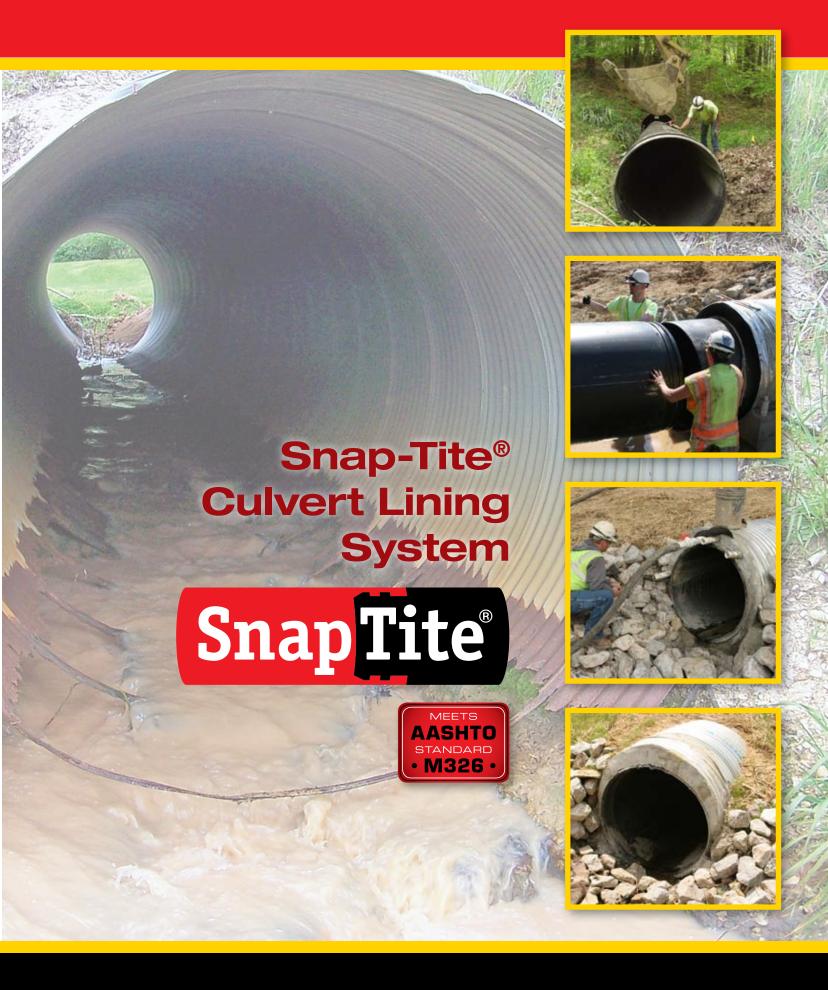
A typical deteriorated culvert close to failure, potentially leading to road collapse and danger to the motoring public.

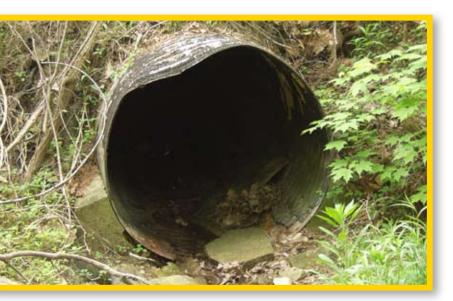
State Departments of Transportation, counties and municipalities are facing a critical problem. Culverts installed forty to fifty years ago are failing at an alarming rate nationwide. Thousands of corrugated metal culverts are so significantly rusted that a danger of sink holes, road collapse or flooding exists. Concrete culverts have cracked or pulled apart at the joints, creating similar dangerous scenarios. Conventional repair methods of the past have been to dig and replace the failed pipe. There is now a dash to find a solution that is economically feasible, quick, and avoids road closures and detours for the motoring public.

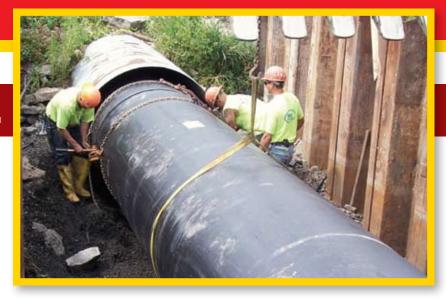
n CMP = 0.024, n Snap-Tite® = 0.00914

Other size Snap-Tite® liners are available for the existing sizes above
